PHOTOGRAPHIC INTERPRETATION REPORT

COMPARISON OF SAM GUIDANCE RADARS AT OSTROV NARGIN, MYS SET-NAVOLOK, AND MOSCOW/FILI AIRFIELD, USSR

NPIC/R-301/63

December 1963

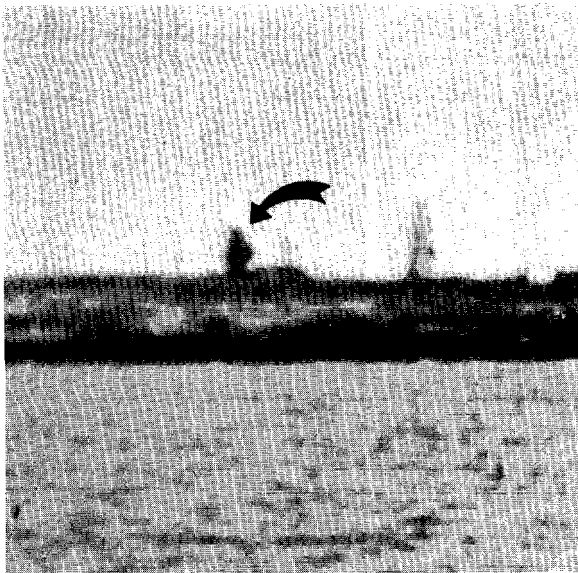
FIGURE 2. CANVAS-COVERED SA-3 GUIDANCE RADAR, OSTROV NARGIN, AS SEEN FROM WEST END OF ISLAND, [REDACTED]

The SA-3 guidance radar at Ostrov Nargin (Figures 1-4) consists of five different components mounted on a chassis, as illustrated in Figure 5. The back-to-back circular section (Figure 5, item I) is attached to the rear of the chassis by a lattice-type mast and may have the capability of being raised or lowered. A cut cylindrical section (item C) is mounted on top of the chassis and appears to have the capability to revolve. Two cut paraboloids (item B), one with a feed and one without, are located on top of the chassis over two troughs (item A). One trough is horizontal and parallel to the front of the chassis; the other is also horizontal, but attached to the side of the chassis. At the base of the chassis, under the latter trough, is a stacked circular section (item G).
